DOT HS-801-969

# CRASHWORTHINESS OF THE SUBCOMPACT VEHICLE

August 1976

Final Report

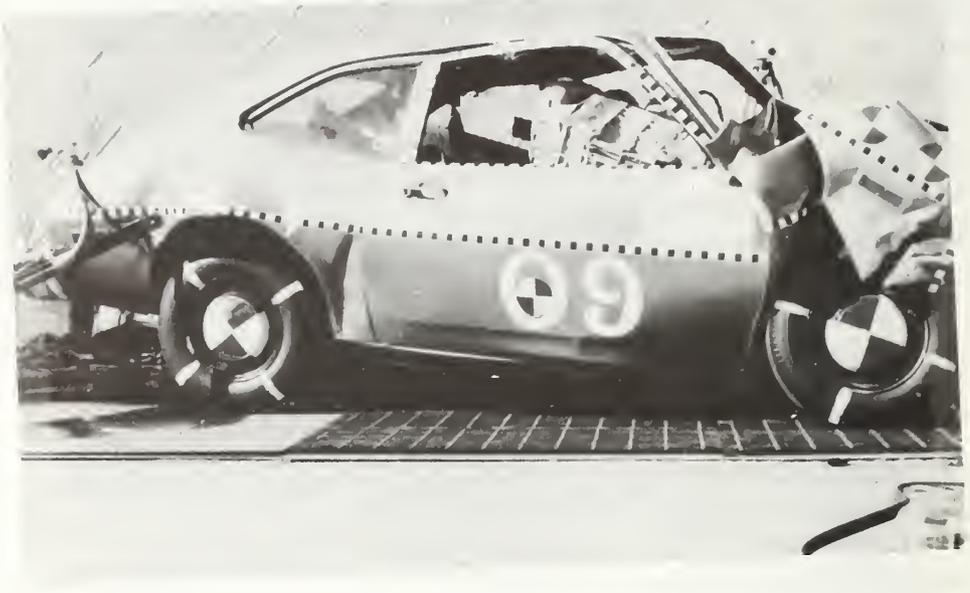
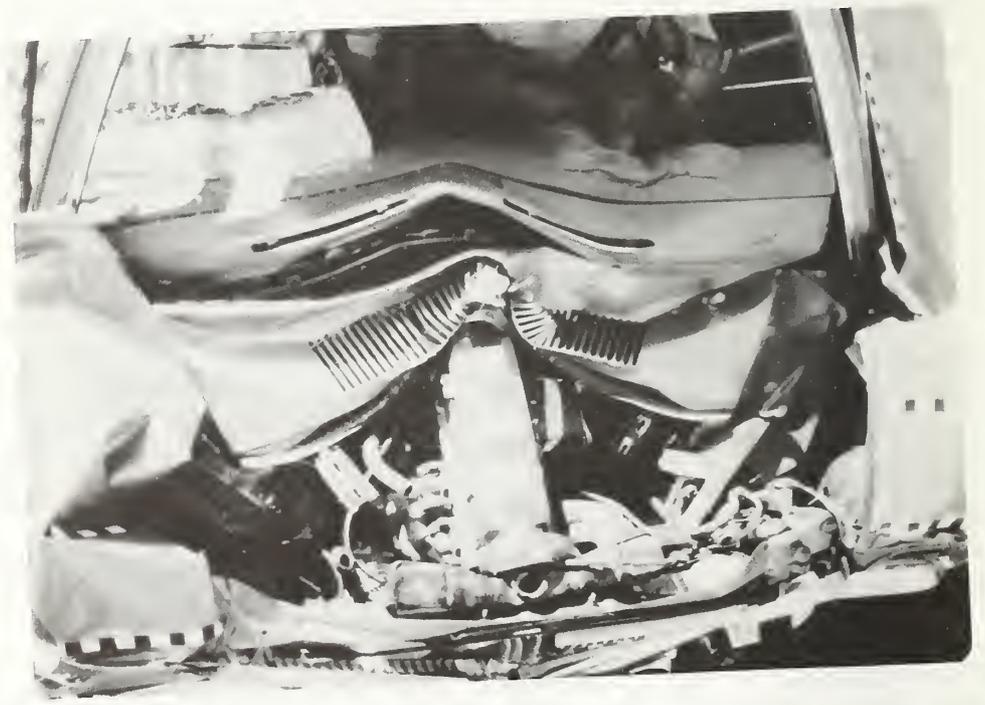
FIGURE 3.26 PHOTOGRAPHIC SUMMARY OF TEST 09

Structural Damage: Damage/deformation was severe throughout the forward two-thirds of the vehicle. The bumper energy absorbers were completely stroked, sheared from their frame mounts, and driven back to the cross member

A. Side View

B. Overhead Engine Compartment

under the engine, where they deformed components of the steering system. The front subframe members were buckled both fore and aft of the engine cross member and suffered plastic bending where they joined the firewall, resulting in energy transfer into, and distortion within, the compartment. The front cross member was both bent rearward and displaced rearward by the movement of the engine and the buckling of the subframe and energy absorbers. Bending failure of this frame member resulted in severe toe-in of the front wheels. The engine was once again the "hard" member in the front end but showed considerably more displacement rearward into the firewall/plenum than had been seen in previous tests. As a result of the massive engine displacement, the entire driveline suffered severe damage. The bell housing was cracked in several places, and the transmission was moved down and to the rear to such a degree that the transmission vibration damper struck the ground. The differential showed noticeable damage, with both axle tubes bent and the universal joint broken. Firewall deformation was marked due to the engine stroke and front frame bending. Front end sheetmetal deformation was severe, with the fenders being buckled and compressed toward the A post.

Baseline Test 09 was a 50-mph frontal barrier impact of a 1974 Pinto two-door sedan. This test was identical to Test 03 (Section 3.3.1.3) except for the higher impact velocity (48.7 mph). The data is summarized in Table 3.5, and an overview of the photographic coverage is shown in Figure 3.26. The complete test report is presented as an attachment to the April 1974 progress report.

Passenger Compartment Intrusion: Significant compartment intrusion resulted from the impact. Although there was little deformation of either the A or B posts, firewall stroke and chassis bending near the B posts caused both doors to jam tight. Additional compartment damage resulted from the marked displacement of the engine. The transmission "hump" and the toeboards adjacent to it were severely deformed, and the driveline tunnel showed deformation along its entire length. Marked buckling of both the front and rear floor boards was also noted. Although the steering column was stroked only slightly,

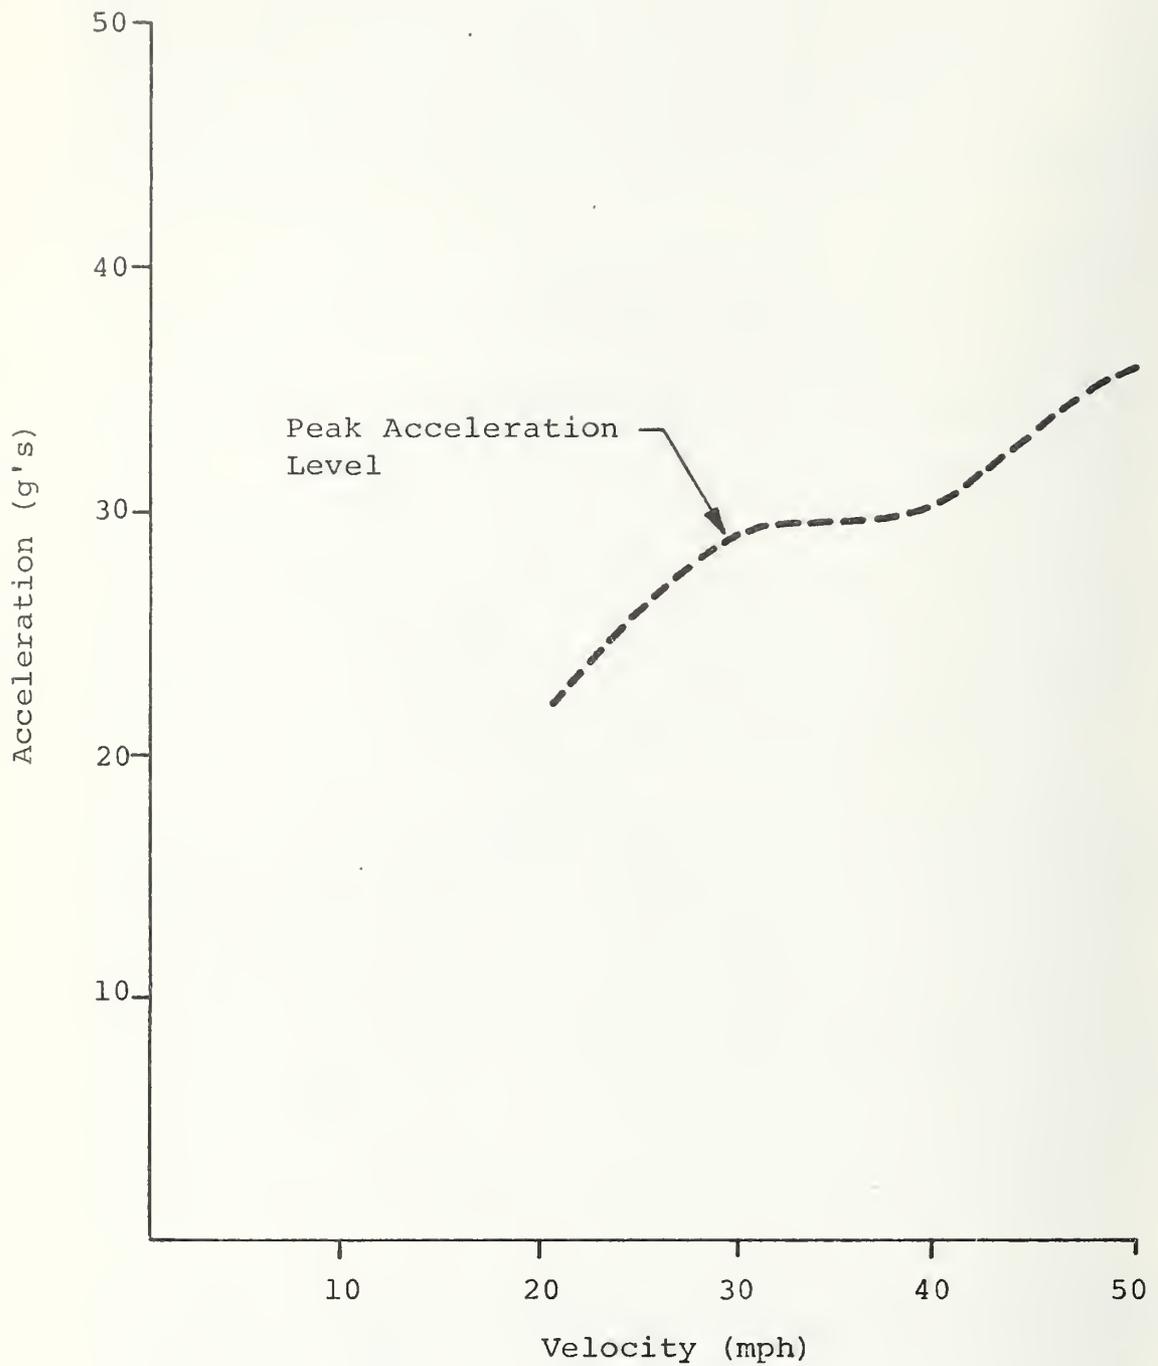
FIGURE 3.28 PEAK ACCELERATION OF BASELINE PINTO AS FUNCTION OF VELOCITY

These baseline tests served two functions. First, they provided a standard of performance for comparison with the modified design. Second, they yielded valuable insight into the behavior of vehicles and possible modifications for improvement of crashworthiness. The critical parameters of dynamic crush, static crush, peak acceleration, and pitch angle are given in Table 3.5; crush data are plotted in Figures 3.27, acceleration in 3.28, and pitch angle in 3.29. Figure 3.30 compares the accelerations recorded at the trunk for these baseline tests.

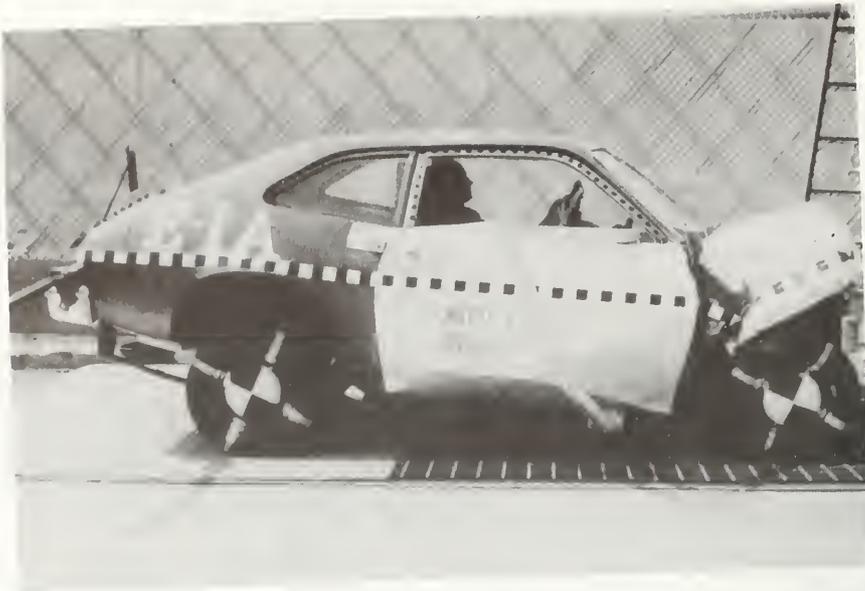
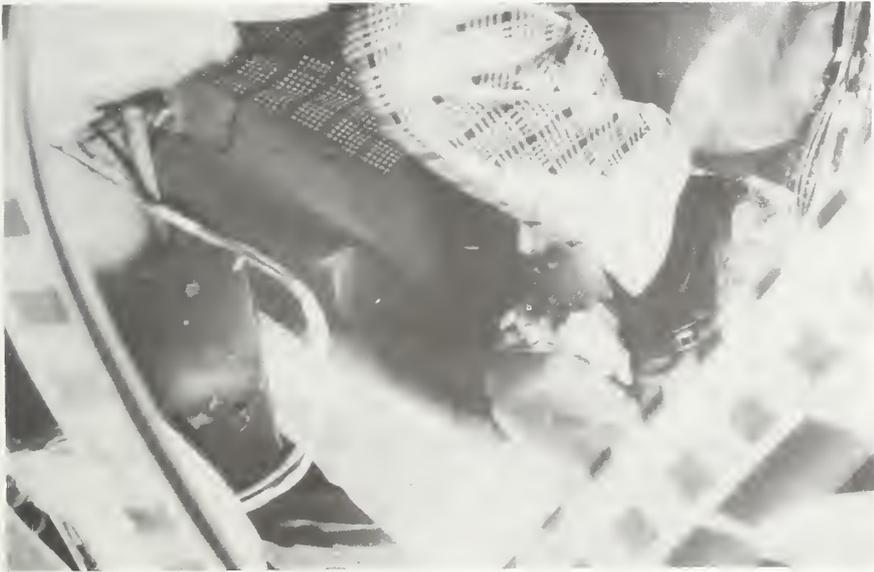
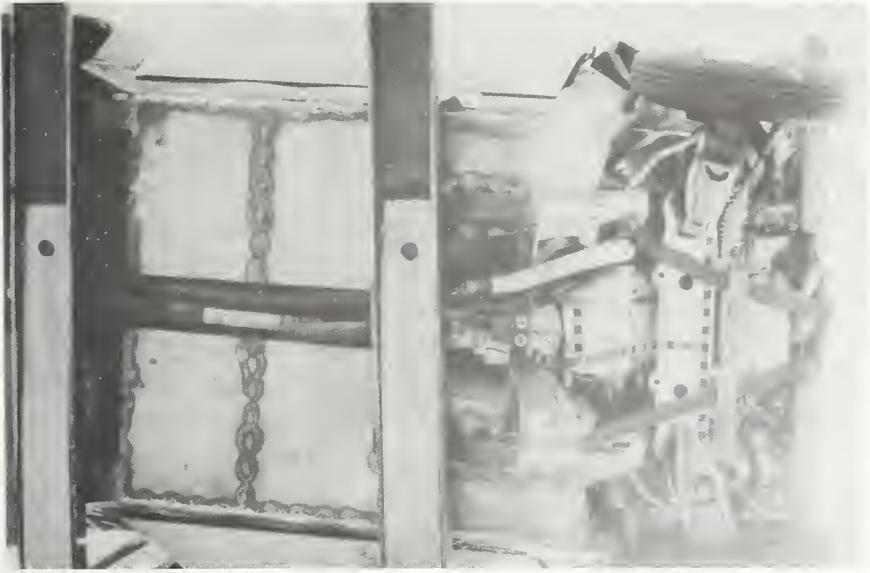
FIGURE 3.33 PHOTOGRAPHIC COVERAGE OF EVALUATION TEST E1A

Exterior Structural Damage: The total crush of the vehicle was 37.3 inches, including complete crush of the plenum chamber. The bumper units stroked as predicted, with the bumper itself undamaged except for local deformation on the back surface. The frame members formed three lobes of the desired accordion fold for approximately 5 inches of crush. They then bent upward in the middle with the bumper unit slider bars forced through the tube walls. The hood section crushed a total of 19 inches. It rotated with the front end rising and the firewall dropping. The fender section aft of the firewall bent downward. The engine cross member assembly broke free as desired, but the aft end caught the plenum and crushed it. The plenum, crushing under the engine impact, did not contact the restraint mounting bar. The doors did not suffer noticeable deformation, but sheetmetal damage prevented post test opening. Some minor sheetmetal buckling occurred in the roof.

Passenger Compartment Intrusion: The upper A posts moved rearward 1.3 and 1.8 inches. The toeboard region suffered damage and intruded into the footwell, yet there was still sufficient room for the feet in the footwell. The movement of the toeboard caused a rotation of the driver restraint system. The tunnel buckled as it was pushed rearward by the engine. No damage was noticeable aft of the mid-compartment lateral member.

A. Side View

C. Driver Foot Well Area

D. Engine

exception of the hardware changes discussed above. An actual velocity at impact of 49.3 mph was attained. The test results are summarized in Table 3.6, with the complete test report included as an attachment to the August 1974 progress report. Photographic coverage is shown in Figure 3.33.

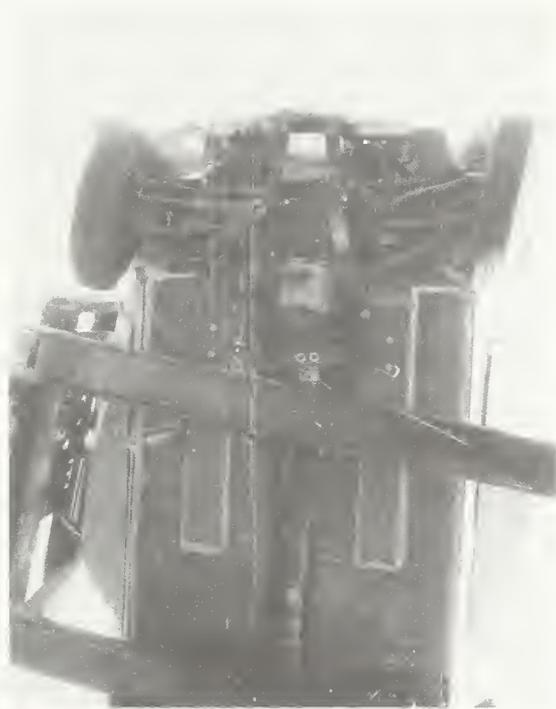
C. Underside View

The test vehicle carried seven accelerometers, five in the compartment and one each in the trunk and on the engine. Data were also gathered by five high-speed cameras, one real-time camera, and pre- and post-test stills. Automatic timers, terminal speed indicator, and an instant-of-impact indicator were also used. Test results were reported in the progress report dated November 1974 under this contract, and are summarized in Table 3.7. Photo coverage is represented in Figure 3.35. All equipment functioned properly except one left front compartment lateral accelerometer.

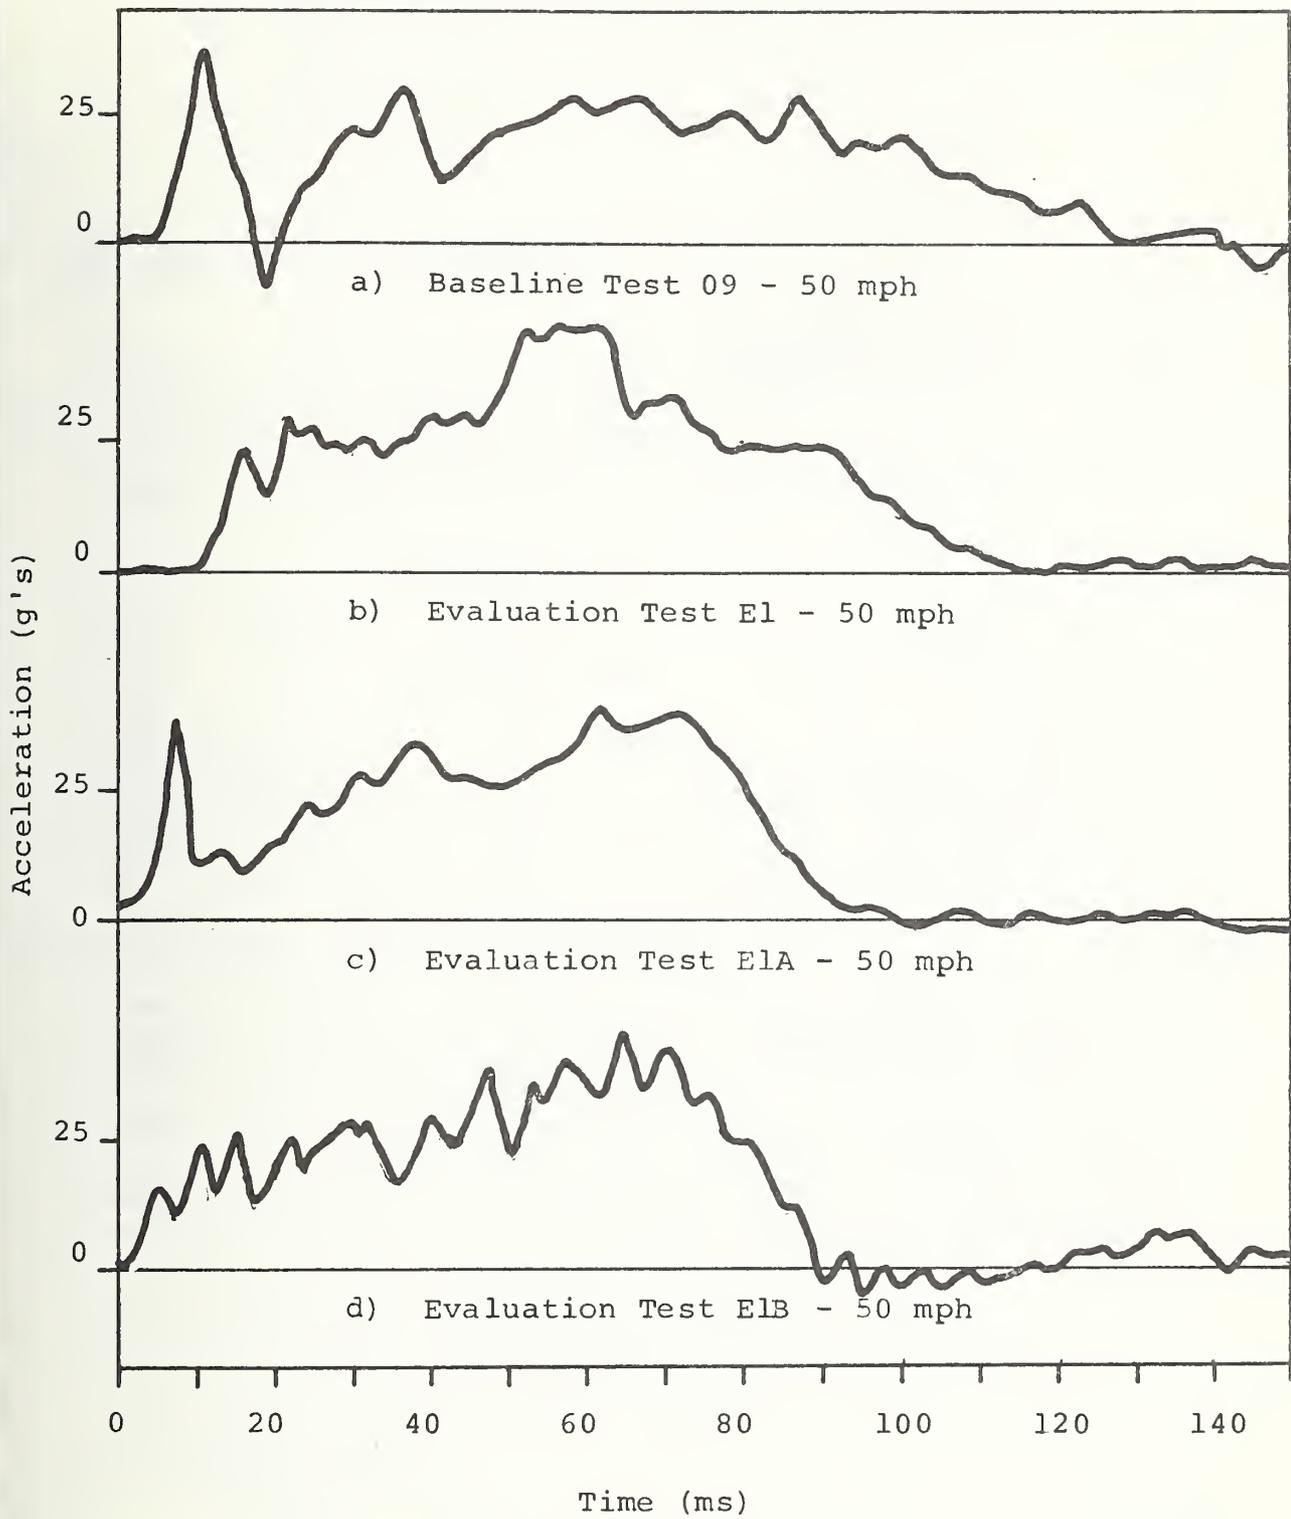
FIGURE 3.34 TRUNK ACCELERATION FOR FRONTAL BARRIER TESTS E1, E1A, E1B, 09

1. The foreframe and sheetmetal follow the same collapse mechanism for both vehicles.

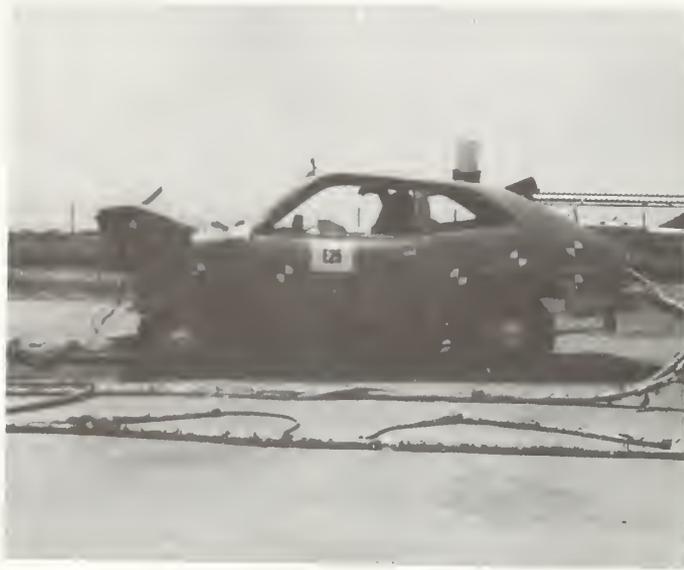
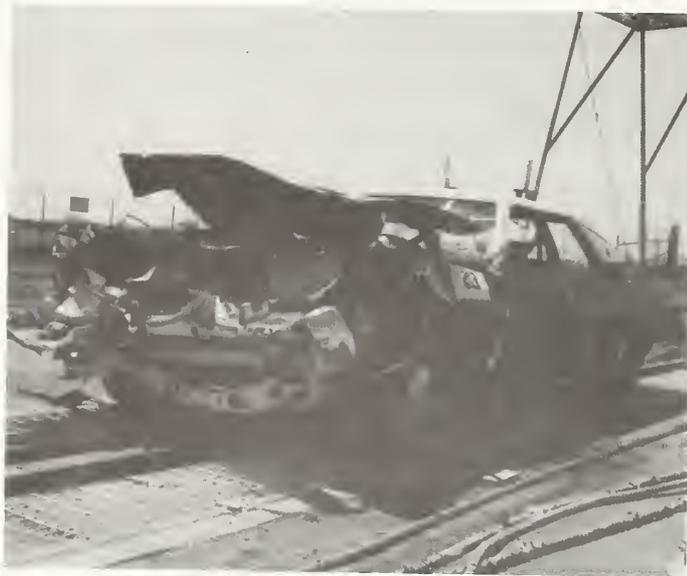
FIGURE 3.36 PHOTOGRAPHIC COVERAGE  
OF TEST E25

A. Post-Test Pinto

B. Post-Test LTD

Exterior Structural Damage: The LTD struck the front of the Pinto aligned, resulting in almost 31 inches of static crush to the Pinto's forward structure, with slightly more distortion on the right hand side than on the left. The measurement of static crush is difficult because the interface between the two vehicles is so irregular. The Pinto appears to have overridden the LTD bumper assembly, forcing the lower Pinto structure -- the fender boxes, the inner fender panels, and forward frame tubes -- to absorb most of the energy. The engine stroked into the enlarged tunnel without striking the tunnel walls. The slightly higher deflections of the passenger side caused this door to be difficult to open, but the driver's door readily opened. The LTD also suffered a generally symmetrical frontal crush. Behind the A post, there was no evident damage.

Interior Compartment Damage: The interior of the Pinto remained essentially undamaged with the exception of minor aft motion, estimated at 2.3 inches, high on the firewall, and some localized buckling of the forward tunnel. No interior damage other than a collapsed upper and lower steering wheel rim and knee/dash contact was noted in the LTD.

The vehicles were instrumented with two triaxial accelerometers, one in the trunk and one on the rear tunnel, two biaxial accelerometers, one on each side at the B posts, and a uniaxial on the engine. The dummies were instrumented with triaxial in the head and chest, and the Pinto driver also had instrumented femurs. Photographic coverage included five high-speed cameras, a real-time camera, and 35 mm pre and post test stills. The complete test report is presented as an appendix to the April 1975 progress report. The physical data is summarized in Table 3.8, with photographic data in Figure 3.36. The actual test velocity of 78.7 mph was well within acceptable limits.

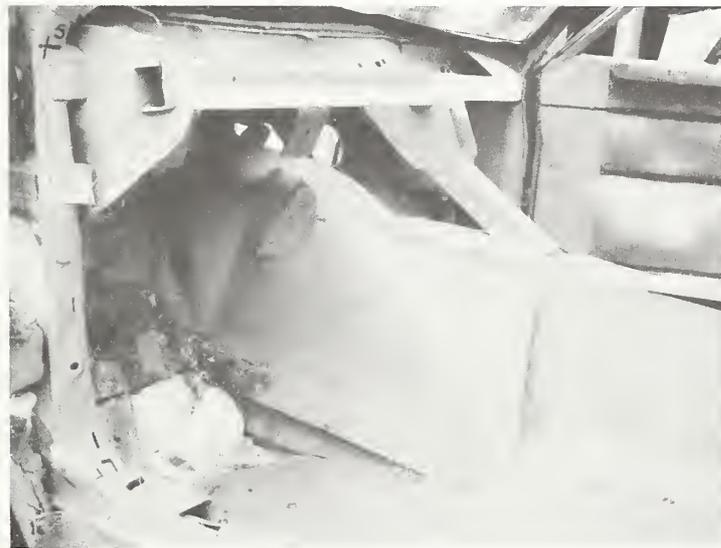
D. Pinto Interior Damage

In this test, the modified Pinto underwent a change in velocity of 50 mph. Both restraint systems worked extremely well, with dummy injury measures substantially lower than the allowable criteria. Figure 3.37 shows the relationship between chest g's and crash pulse g's. In this figure, it is obvious that the restraints transmitted very low g amplification over the crash pulse g's, i.e., generally less than 1.0. The final post-crash position of the dummies was very similar to their pre-crash position.

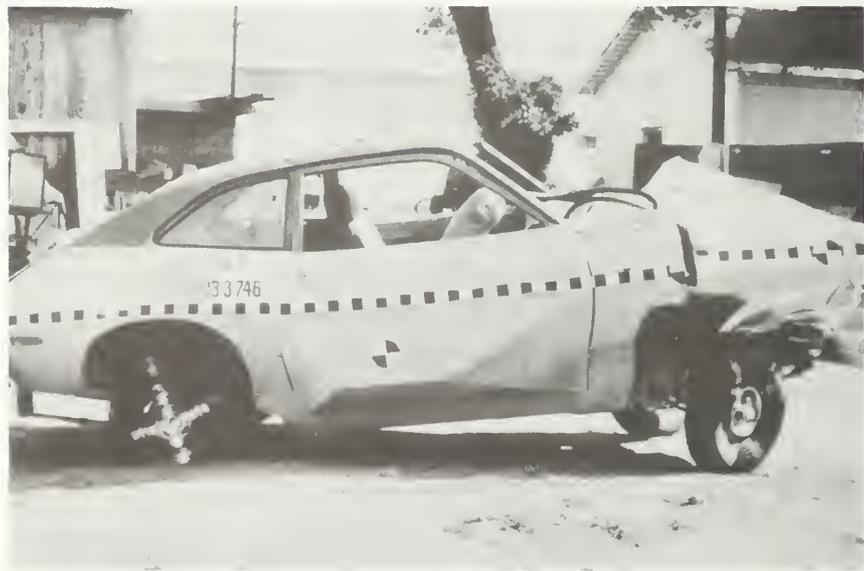
FIGURE 3.41 PHOTOGRAPHIC COVERAGE OF TEST E15

B. Post-Test Right Side View

This test was in support of evaluation of the modified design in the oblique frontal mode. Actual test velocity was 45.2 mph. The test vehicle carried seven accelerometers; test data are summarized in Table 3.9. Photographic coverage included high-speed and real-time motion pictures and pre- and post-test stills; photo coverage is summarized in Figure 3.41. Automatic timers, terminal velocity speed trap, and visual instant-of-impact indicator were also used.

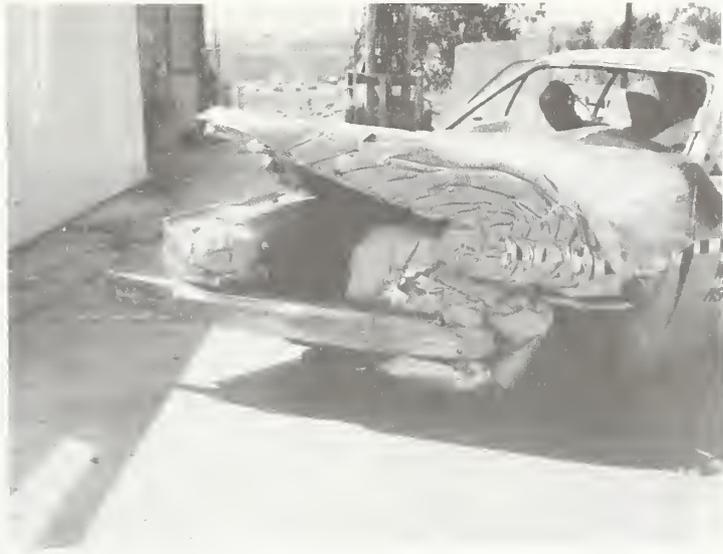
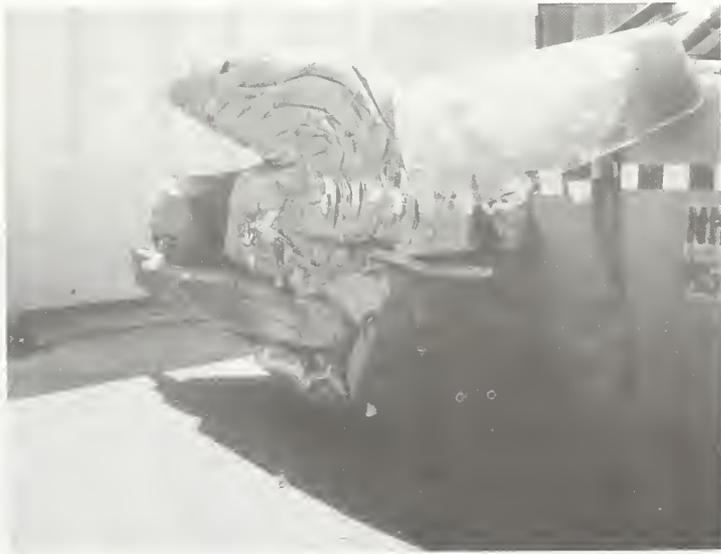
FIGURE 3.42 PHOTOGRAPHIC COVERAGE OF TEST E24

Beyond the perforation of the left toeboard and some denting of the right toeboard, the interior of the vehicle was essentially undamaged. Incipient buckling was noted at the junction areas of the tunnel and on the left front roof.

A. Left Front Quarter

B. Left Front

D. Left Toeboard

The recorded intrusion of 14 inches at the upper inside left toeboard reflects the final position of a light gage sheet metal cover over the toeboard foam which was deflected some 4 to 6 inches further than the structure as the left stub frame detached. Thus a final intrusion of 8 to 10 inches at this point is probably more accurate.

This test supported the evaluation of the modified design in the frontal oblique crash mode. Instrumentation included seven accelerometers, high-speed and real-time motion pictures, etc. Data are summarized in Table 3.9; photo coverage is represented in Figure 3.42. This test was reported on in the August progress report under this contract. This vehicle was equipped with an advanced restraint system and instrumented dummies in connection with another contract; some dummy test results were lost through operator error, but available data indicated that the occupants were successfully protected. Actual impact velocity was 49.4 mph.

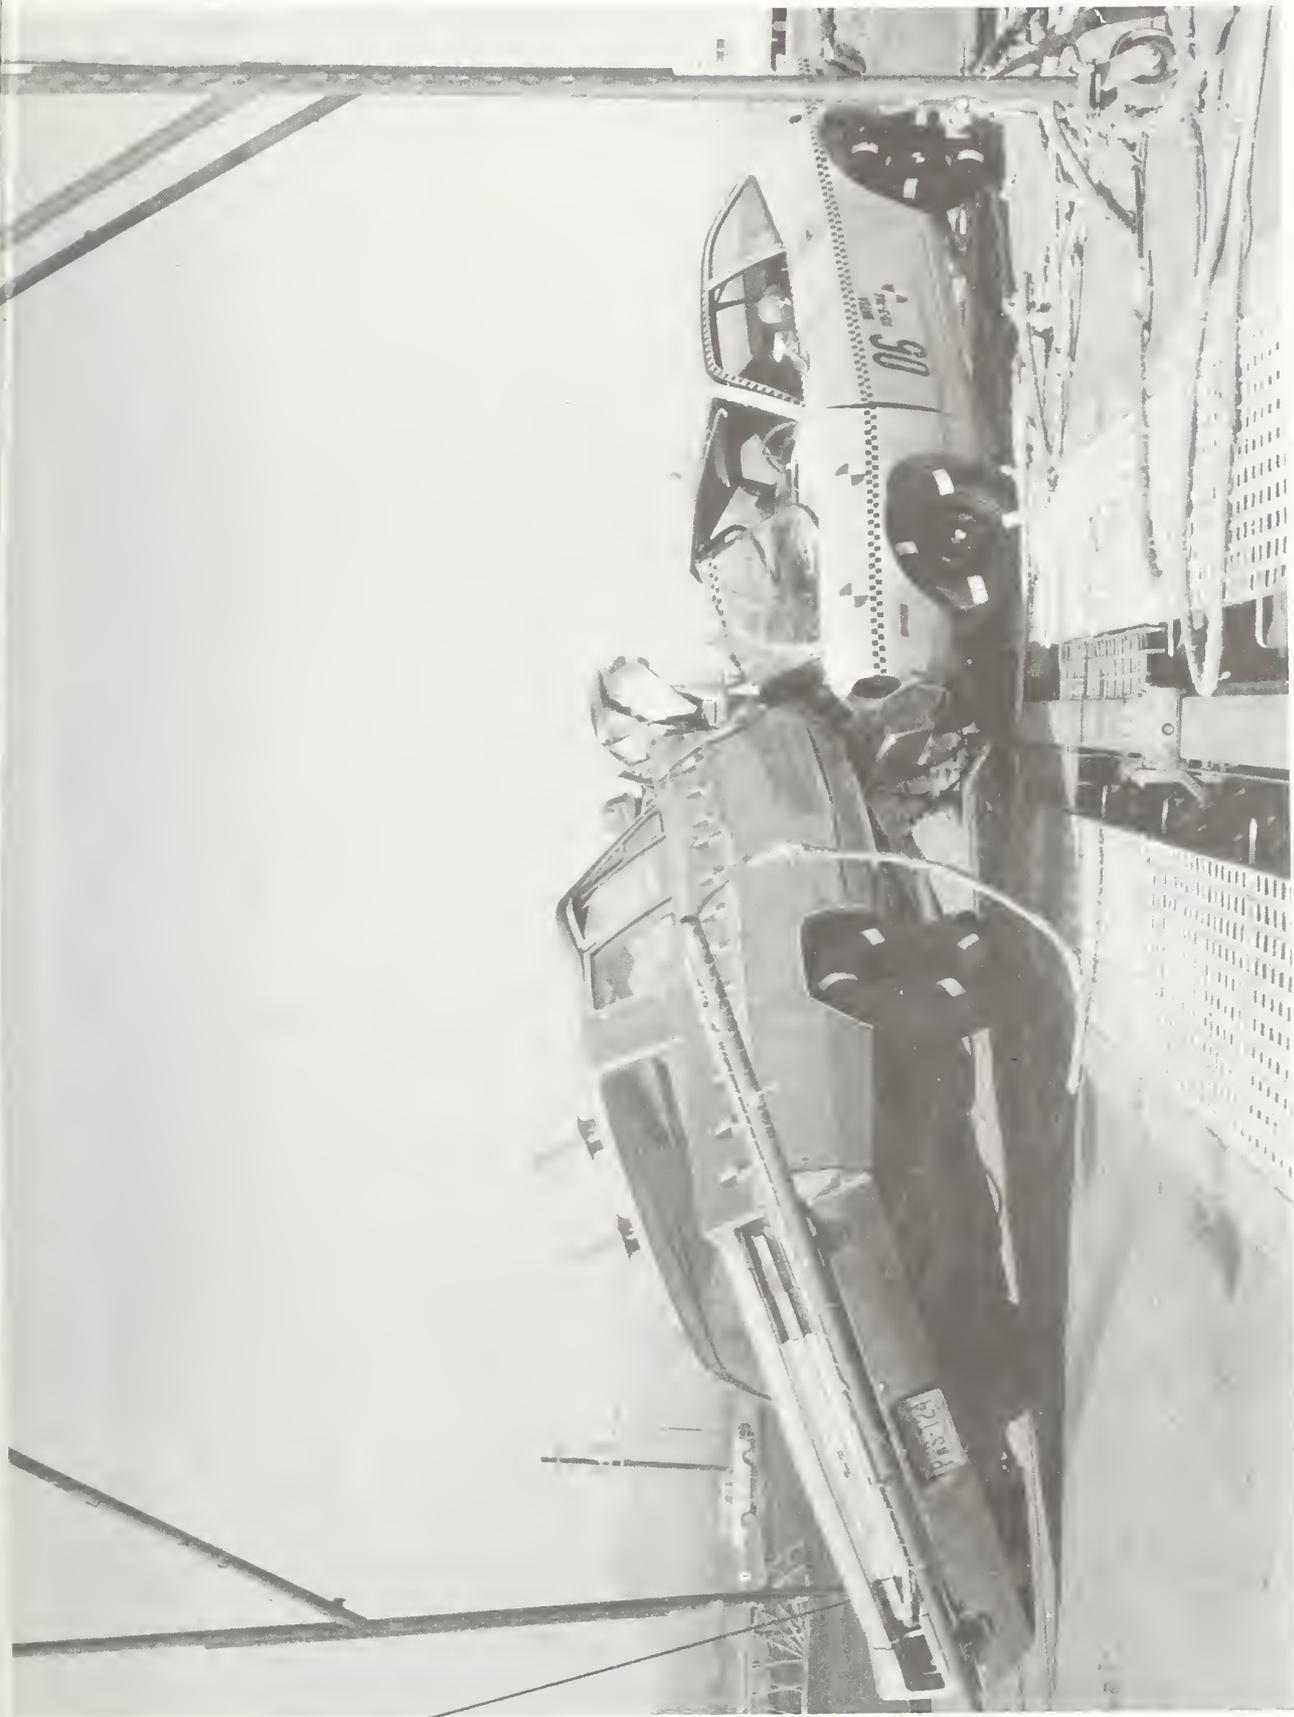
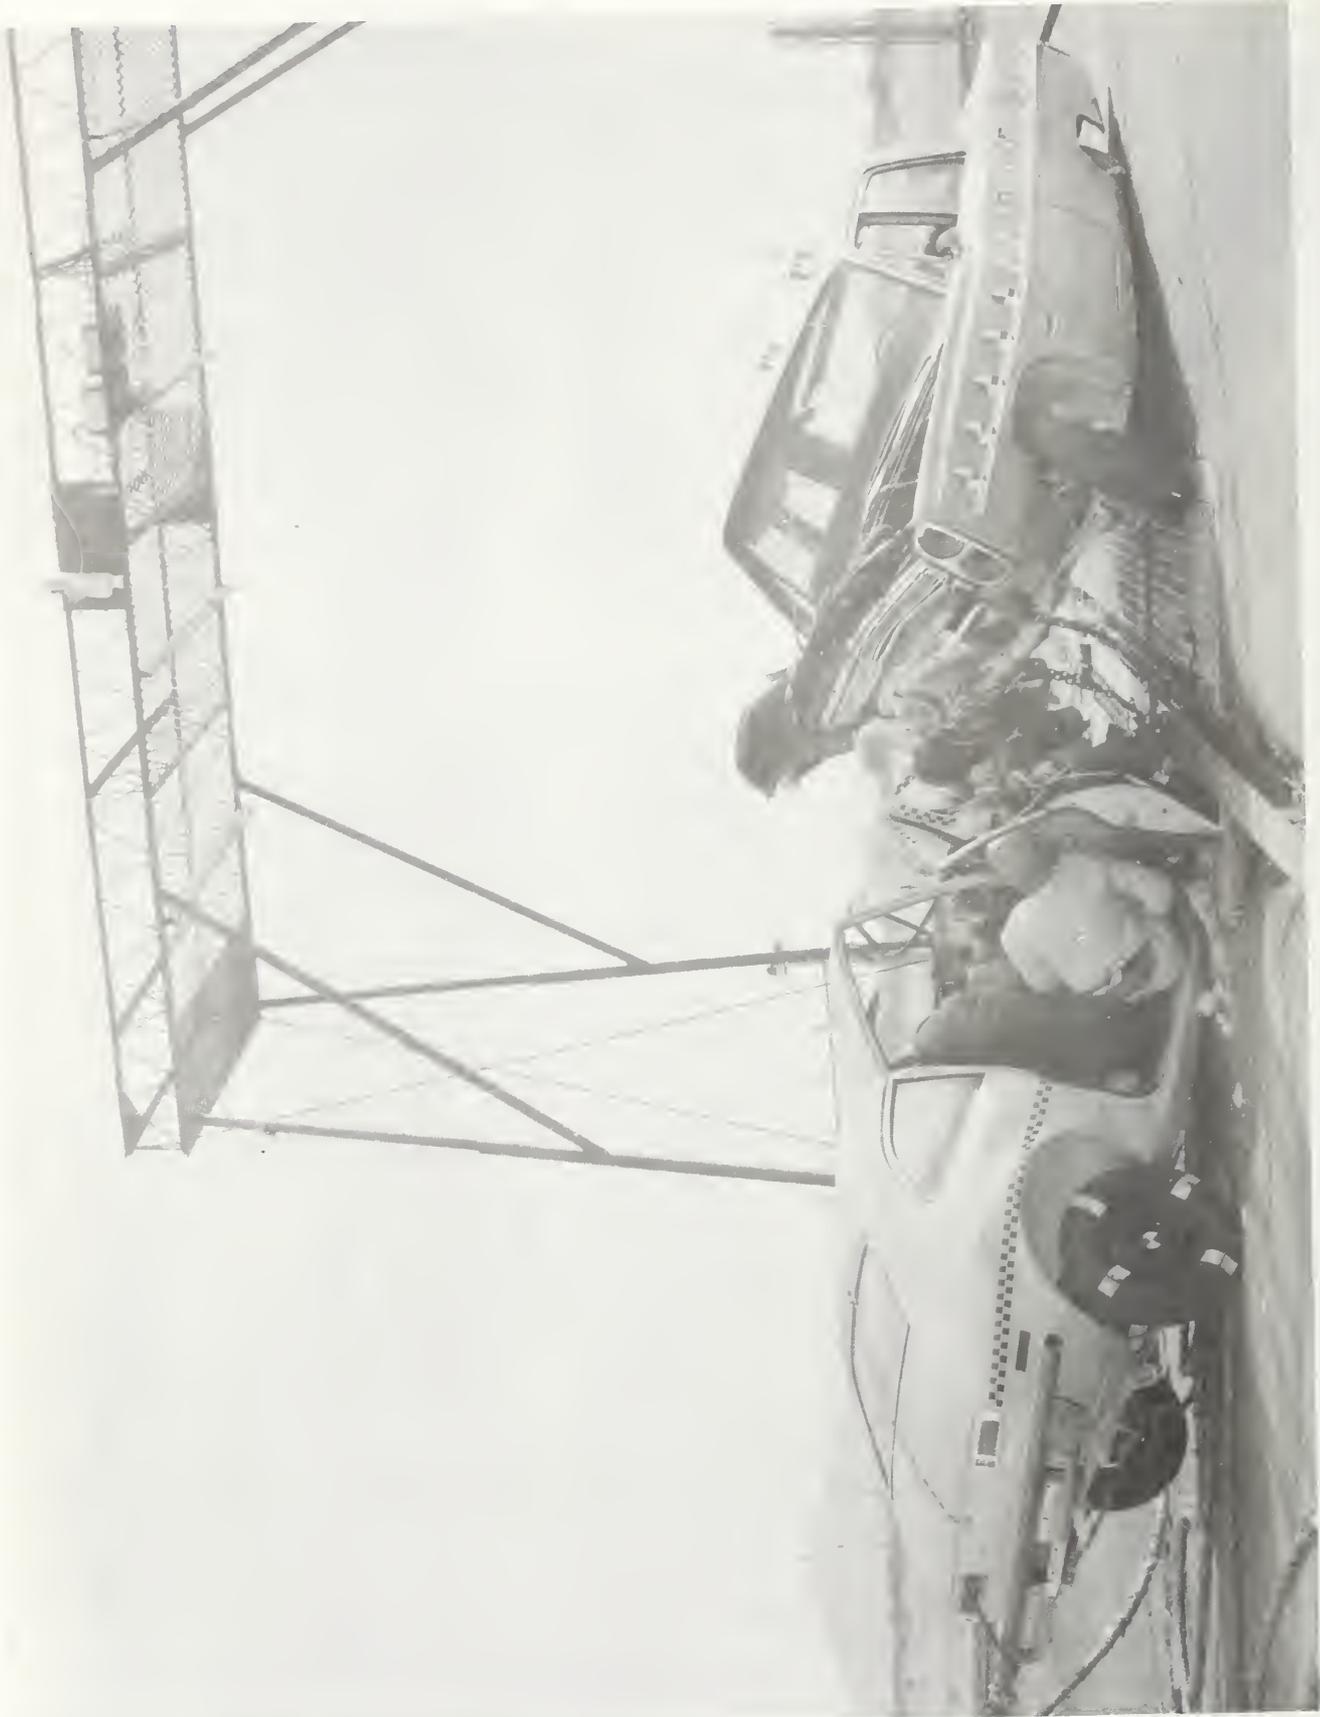
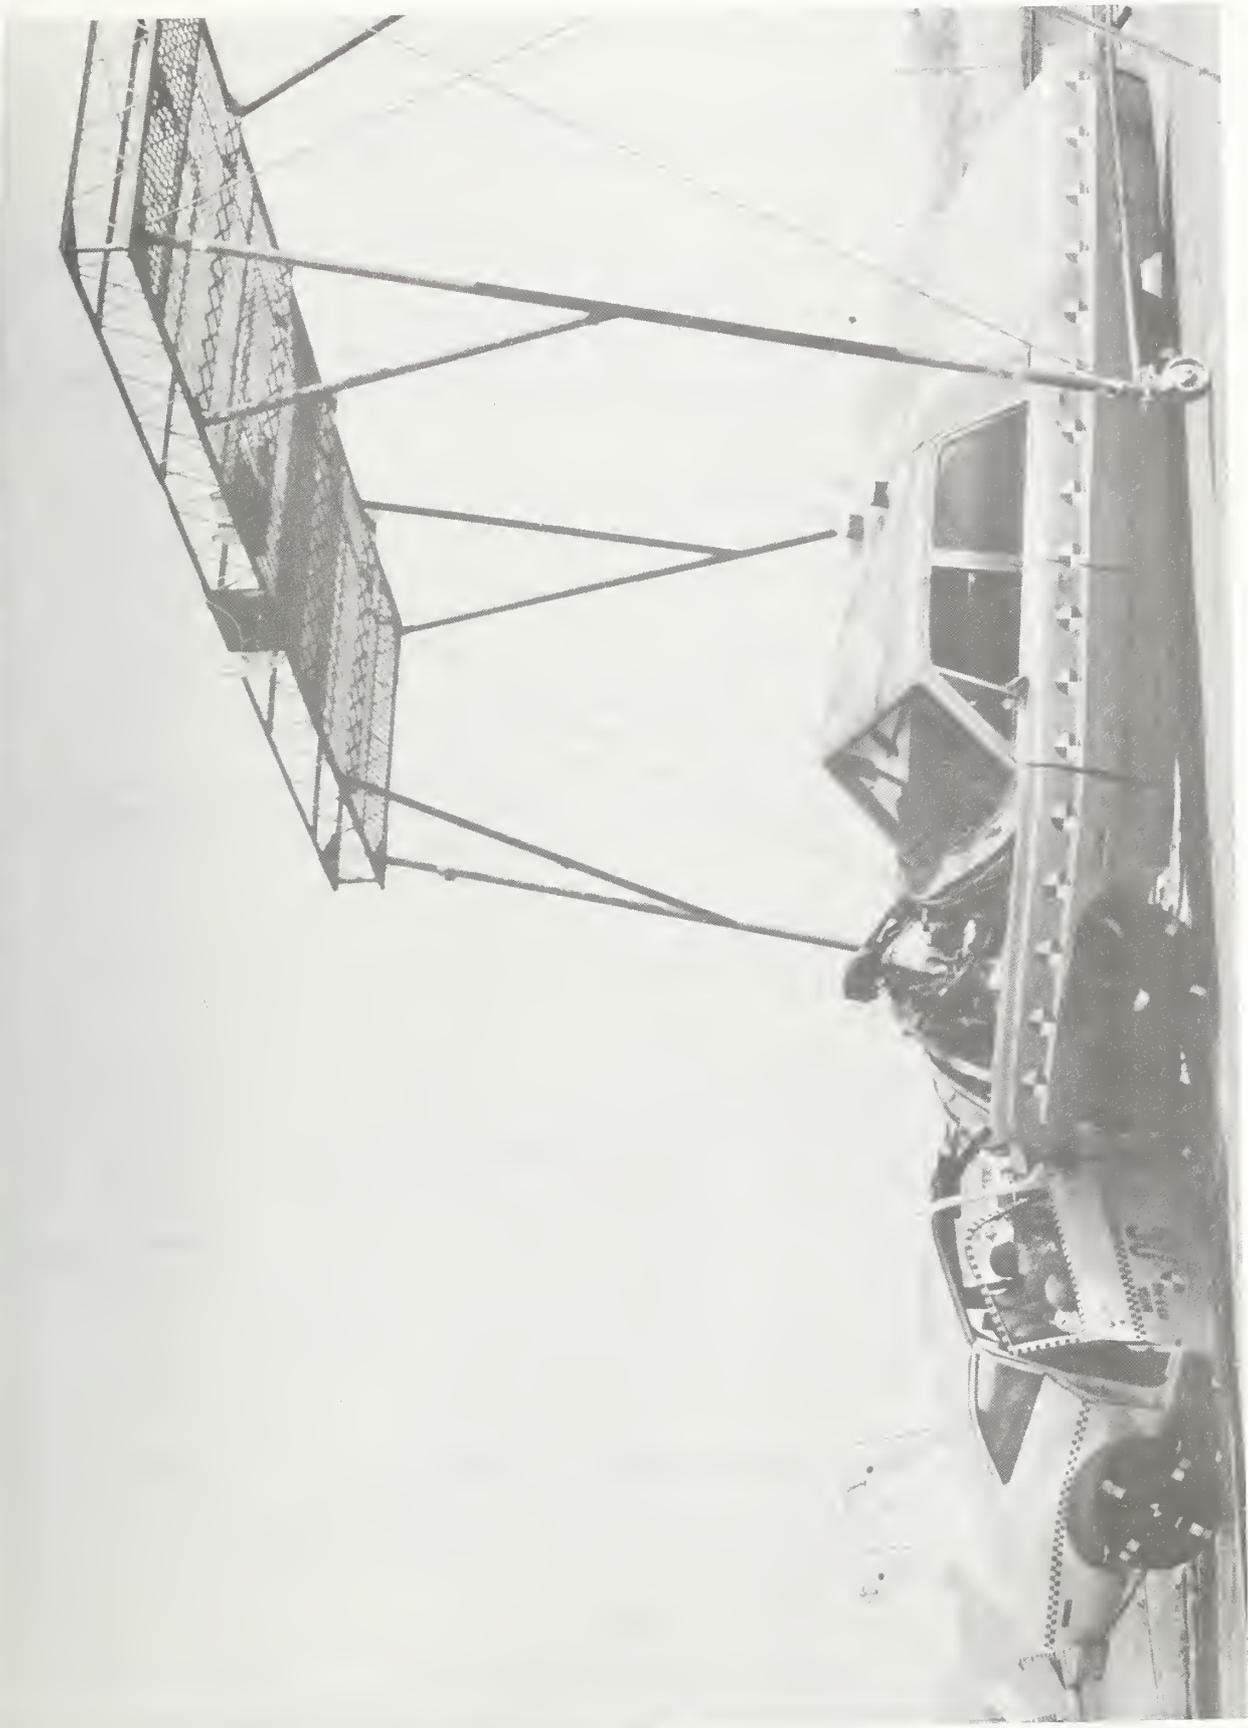
FIGURE 3.43 PHOTOGRAPHIC COVERAGE OF BARRIER TEST 06

A. Post-Test View Along Plymouth Travel Direction

B. Post-Test View Along Pinto Travel Direction

C. Post-Test Overall View
